**RIPARIAN COMMUNITY AND BANK RESPONSE TO MANAGEMENT:
A Comparison of Old and New Surveys in the Prineville District,
Bureau of Land Management.**

Christine Rasmussen, Graduate Research Assistant, Dept. of Rangeland Resources, Oregon State University, Corvallis, OR 97331.

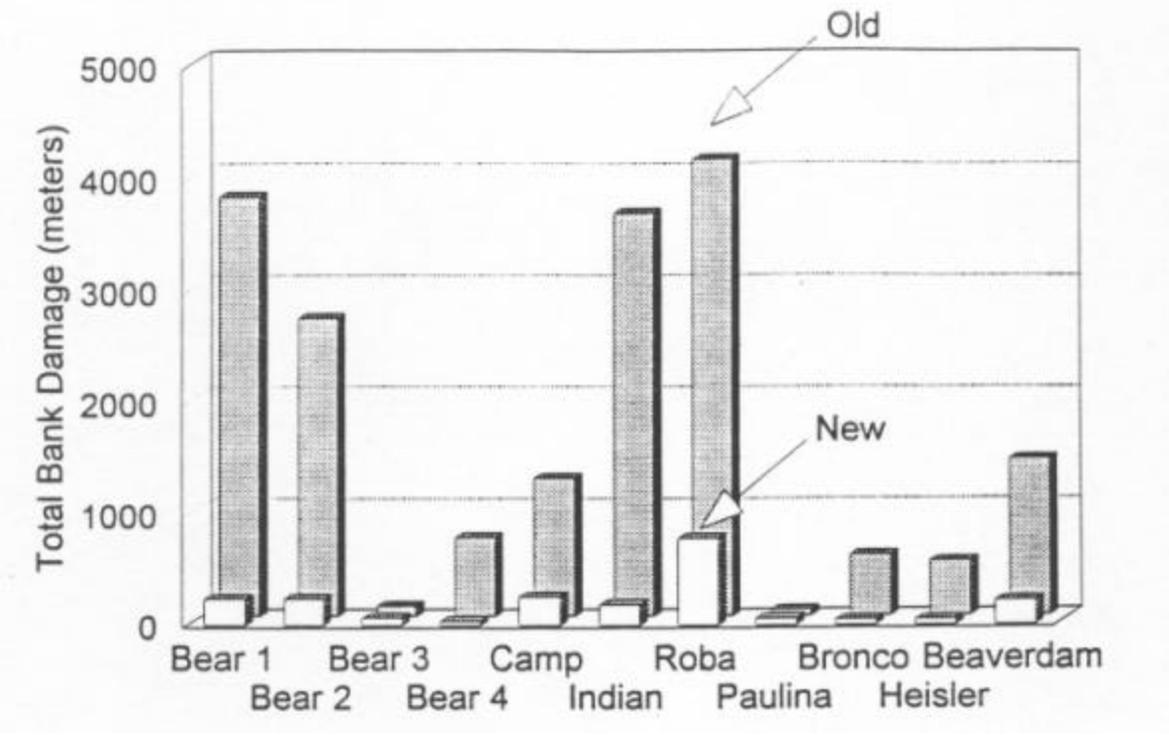
Figure 2

The riparian area in this section increased from 7.78 acres in 1978 to 15.88 acres in 1994 (Fig. 1). The total bank damage dropped 94 percent, from 3772 meters in 1978 to 242 meters in 1994 (Fig. 2). The largest drop was in natural bank damage (3653 meters to 199 meters) with a large

The riparian area increased from 5.42 acres in 1978 to 9.00 acres in 1994 (Fig. 1). Bank damage is only 9 percent of what it was in 1978, a drop from 2678 meters to 245 meters (Fig. 2). The 30 meters of bank damage due to livestock in the present survey occurred immediately downstream of the enclosure in a water gap. Of the 152 meters of juniper rip-rap placed, 39 meters were exposed and dry at the time of this year's survey (success rate of 73 percent).

The total riparian area for Indian Creek has increased from 4.9 acres in 1978 to 8.00 acres in 1994 (Fig. 1). Bank damage (Fig. 2) is much less now than it was in the previous survey, only 5 percent of the original (from 3625 meters to 191 meters), and cutbank lengths (Fig. 3) dropped by 83 percent (from 876 meters to 151 meters). Composition of the riparian zone changed considerably since the original survey (Table 3). The grass-sedge rush component increased 17 percent, the litter component increased 11 percent, percentage of bare ground dropped 11 percent, and percentage of the riparian zone composed of shrubs and trees dropped 22 percent (Table 1). Flow is intermittent, as it was in the original survey. Secondary and old channels make up significant portions of the new riparian area, and were not recorded at all in the old survey (Table 3). Trout of appreciable size

Figure 2. A comparison of the total bank damage, old and new, per surveyed section of stream. Bear 1 = River mile 4.25 - 7.75; Bear 2 River mile 10.0 - 12.5; Bear 3 = River mile 13.25 - 13.5; Bear 4 = River mile 15.0 - 16.25.

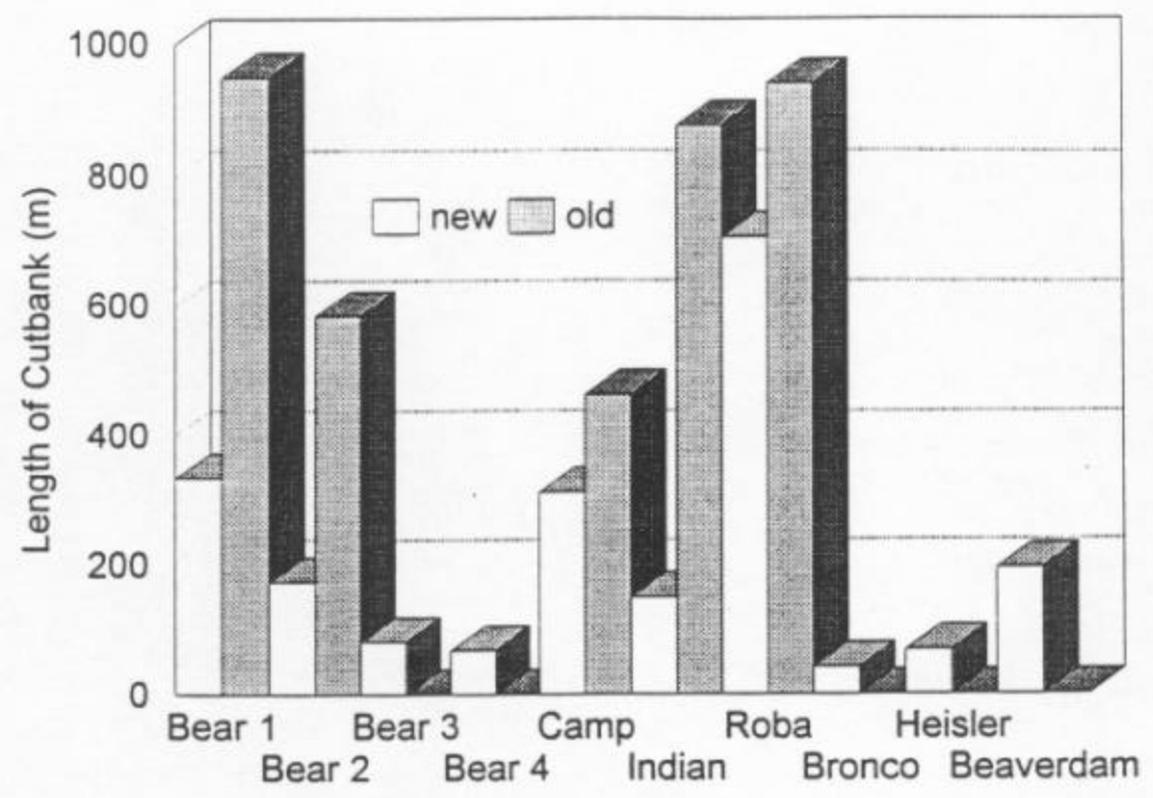
Figure 3

In this year's survey, the riparian area was much greater. Beavers have moved into the area, cutting juniper trees, flooding juniper and sage plants, and impounding water and sediment . One beaver dam at river mile 15.75 reaches nearly from hillslope to hillslope (48 meters), and has been maintained for several years. No cutbanks were recorded in 1978, but 68 meters were recorded in 1994 (Fig. 3).

The total riparian area of Camp Creek increased from 1.43 acres in 1978 to 6.95 acres in 1994 (Fig. 1). A large portion of the area increase is due to sediments captured by the gabions. The communities upstream and immediately downstream of the gabions comprised 3.2 acres of the total riparian area for the mile-long reach. The total bank damage decreased from 1244 meters to 261 meters (Fig. 2). In the 1988 survey, bank damage was not broken into natural, trampling and other causes. Approximately 170 meters of juniper rip-rap were placed in this section of stream (not all of it below gabions), 8 meters of which were labeled ineffective. This rip-rap was probably placed the same year as the fencing and gabions. The length of cutbank community dropped from 463 meters in 1978 to 312 meters in 1994, a 33 percent decrease (Fig. 3).

The total riparian area of Roba Creek increased from 2.39 to 4.07 acres since the original survey (Fig. 1). While this stream has the highest amount of bank damage reported this year (791 meters), this number is less than one-fifth of the 1978 reported damage (4103 meters) (Fig. 2). In the original survey, a significant portion of the bank damage was due to logging activities. Cutbank lengths have decreased little over the years, from 940 meters in 1978 to 706 meters this year (Fig. 3).

Figure 3. A comparison of old and new total lengths of cutbank community for all sections except Paulina Creek. Bear 1 = River mile 4.25 - 7.75; Bear 2 = River mile 10.0 - 12.5; Bear 3 = River mile 13.25 - 13.5; Bear 4 River mile 15.0 - 16.25.
