**RIPARIAN COMMUNITY AND BANK RESPONSE TO MANAGEMENT:
A Comparison of Old and New Surveys in the Prineville District,
Bureau of Land Management.**

Christine Rasmussen, Graduate Research Assistant, Dept. of Rangeland Resources, Oregon State University, Corvallis, OR 97331.

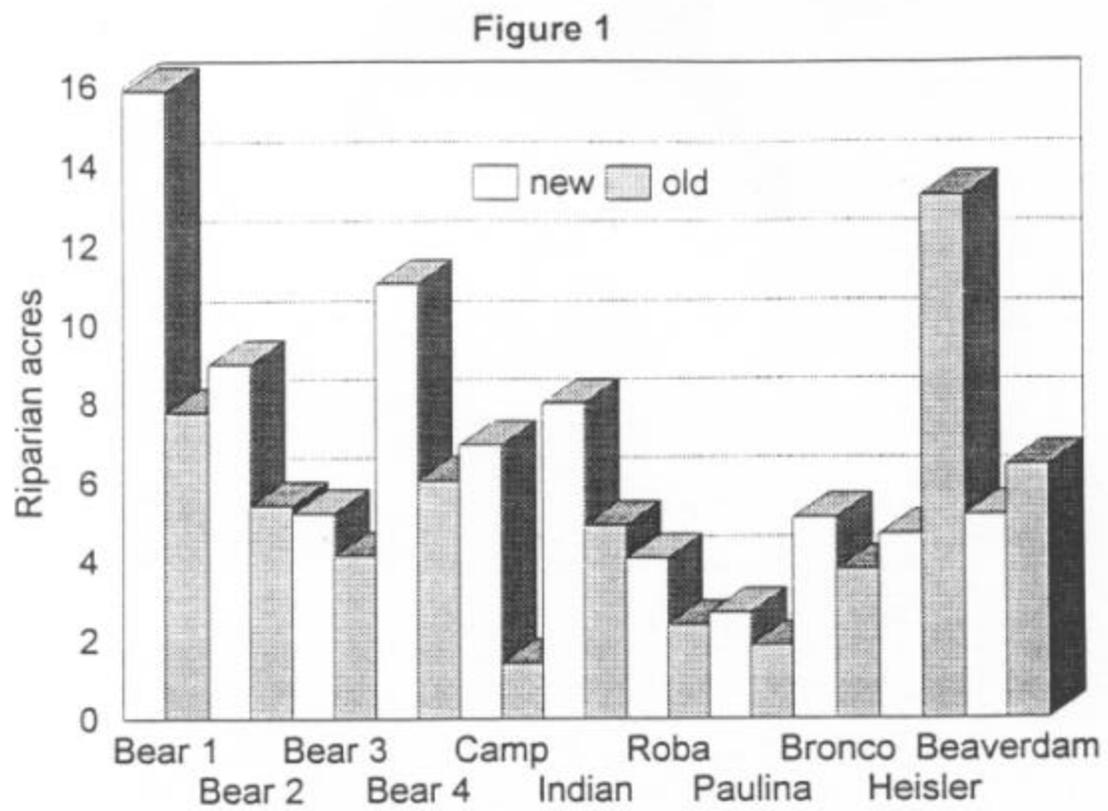
Figure 2

The total riparian area for Indian Creek has increased from 4.9 acres in 1978 to 8.00 acres in 1994 (Fig. 1). Bank damage (Fig. 2) is much less now than it was in the previous survey, only 5 percent of the original (from 3625 meters to 191 meters), and cutbank lengths (Fig. 3) dropped by 83 percent (from 876 meters to 151 meters). Composition of the riparian zone changed considerably since the original survey (Table 3). The grass-sedge rush component increased 17 percent, the litter component increased 11 percent, percentage of bare ground dropped 11 percent, and percentage of the riparian zone composed of shrubs and trees dropped 22 percent (Table 1). Flow is intermittent, as it was in the original survey. Secondary and old channels make up significant portions of the new riparian area, and were not recorded at all in the old survey (Table 3). Trout of appreciable size

The total riparian area of Roba Creek increased from 2.39 to 4.07 acres since the original survey (Fig. 1). While this stream has the highest amount of bank damage reported this year (791 meters), this number is less than one-fifth of the 1978 reported damage (4103 meters) (Fig. 2). In the original survey, a significant portion of the bank damage was due to logging activities. Cutbank lengths have decreased little over the years, from 940 meters in 1978 to 706 meters this year (Fig. 3).

The riparian area of Bronco Creek increased from 3.79 acres in 1978 to 5.11 acres in 1994 (Fig. 1). Total bank damage decreased from 551 meters to 48 meters (Fig. 2). In the original survey, no cutbank community was recorded, but in this year's survey, 42 meters were recorded (Fig. 3).

Cutbanks in this stream were the most severe of the three, with almost 200 meters this year, and none recorded before (Fig. 3). Bank damage has decreased from 1415 meters to 219 meters (Fig. 2). Bank damage due to logging activities (1133 meters) was reported in the original survey.

Bank damage dropped from 494 meters in 1978 to 52 meters in 1994 (Fig. 2), while the length of cutbank community increased from zero to 69 meters (Fig. 3). Over 100 meters of the original bank damage was due to logging activity.

Figure 2. A comparison of the total bank damage, old and new, per surveyed section of stream. Bear 1 = River mile 4.25 - 7.75; Bear 2 River mile 10.0 - 12.5; Bear 3 = River mile 13.25 - 13.5; Bear 4 = River mile 15.0 - 16.25.
