Coeur d'Alene Geographic Area, Current Condition; Aquatic Habitat Condition Map

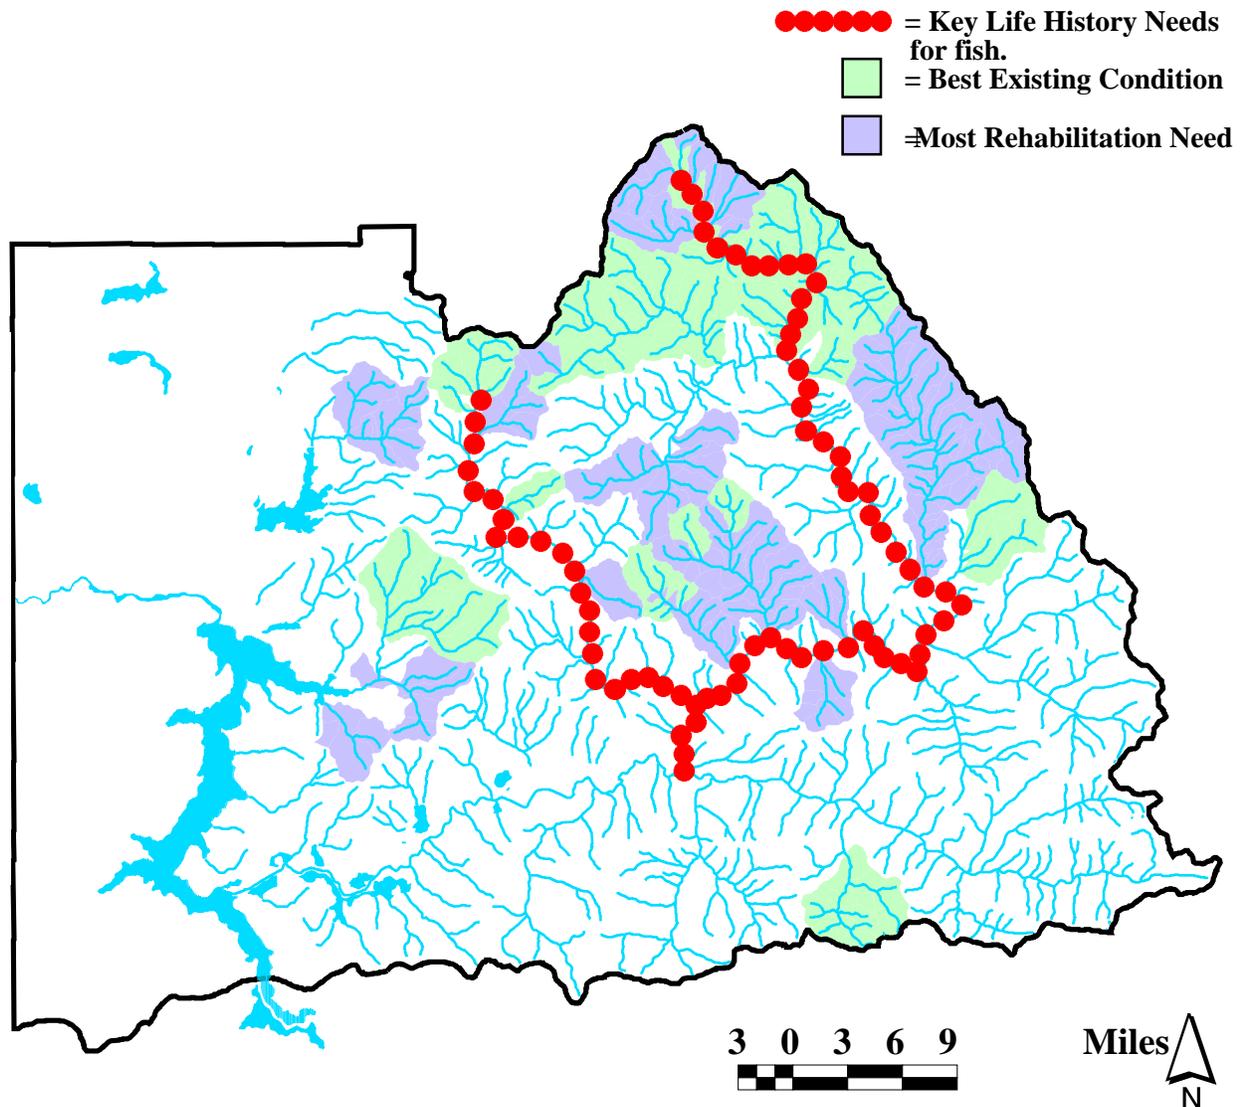
Figure . Much of the Coeur d'Alene area aquatic habitat has been heavily impacted by past activity. The best existing (most ecologically intact watersheds) shown on this map also have some restoration needs. In addition to best existing condition areas, watersheds with most rehabilitation needs are shown, and the remaining areas are also important to the long term persistence of native fish. "Key life history needs" rivers include the North Fork and Little North Fork Coeur d'Alene River.
